## Creighton Mine, Sudbury, Canada

**Customer:** Vale Inco  
**Location:** Creighton Mine, Sudbury, Ontario, Canada  
**Year of Completion:** 2007  
**Hoist supplied:** 18'- 0" Diameter Double Drum Production Hoist

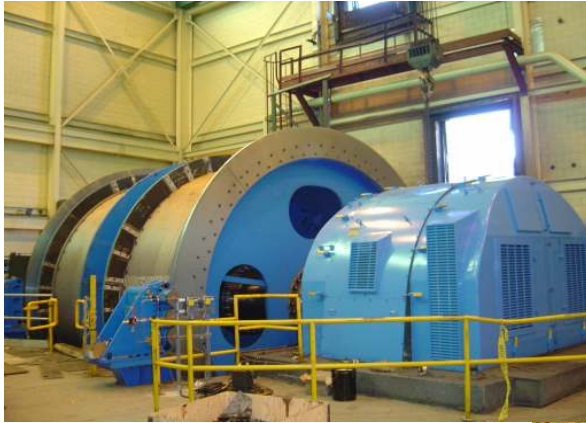
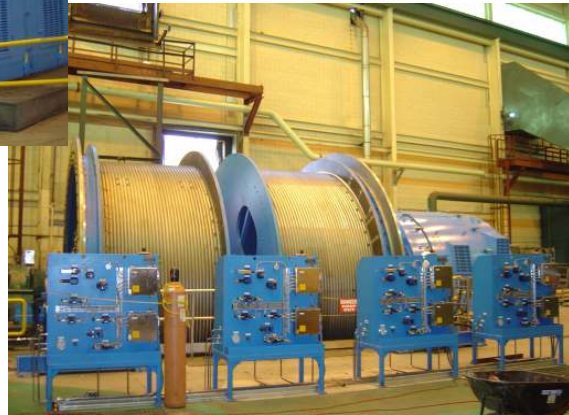
DavyMarkham was tasked with producing a new hoist that was to be built up from existing bearings, and also required to fit all pre-existing foundations.

The former hoist had become cracked due to fatigue and had severe brake holding problems. As well as the rebuilding the hoist, DavyMarkham was also responsible for the refurbishment of the existing drive motor.

New disc brakes were installed in place of the existing calliper brakes together with a four channel brake system with ABB electrical controls.

Creighton mine is a highly productive mine, therefore the customer allowed only a limited shut down period of one month. During this period DavyMarkham successfully removed the existing hoist, installed and commissioned the new hoist allowing it to be back in production after a minimal shutdown time.
